# San Francisco Creek Bridge

# Emergency North Embankment Restoration

### Post-storm site inspection **North Embankment:**

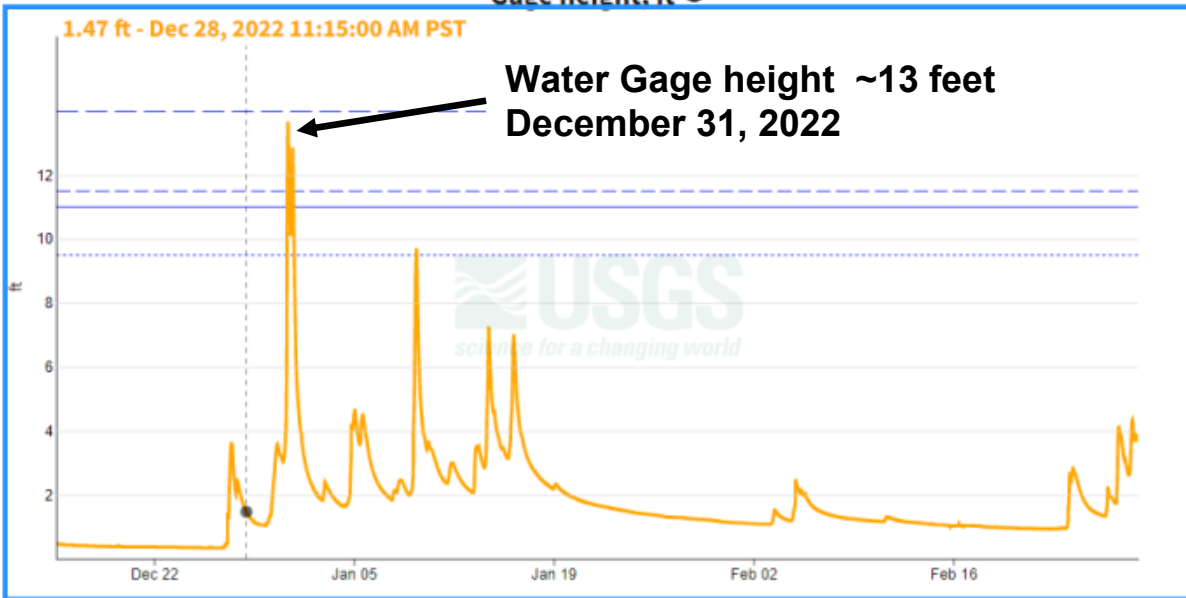
# San Francisquito Creek Bridge Winter Storm Events

Current: — Provisional  
Action stage - - - 9.5 ft  
Minor flood stage — 11 ft  
Moderate flood stage - - 11.5 ft  
Major flood stage — 14 ft

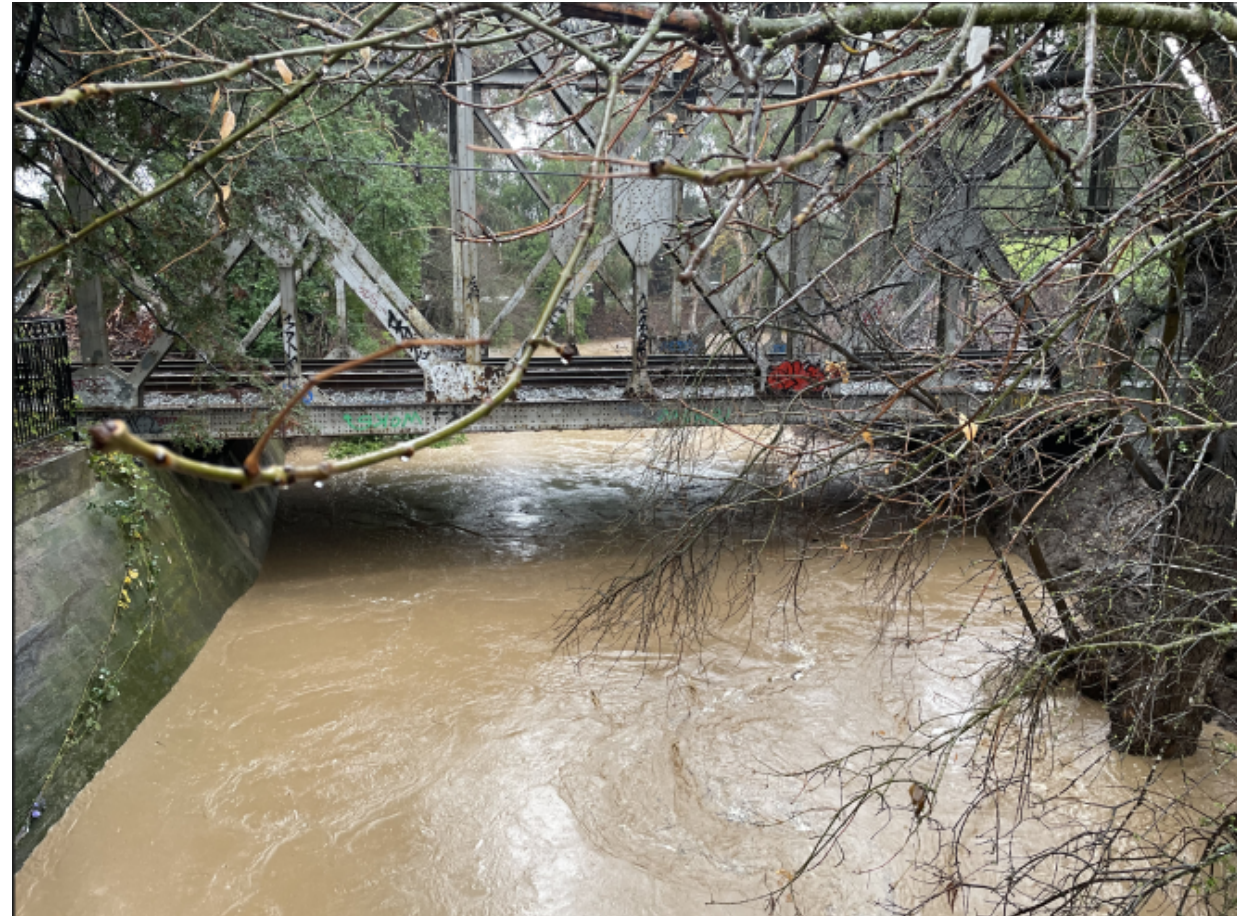
## San Francisquito C a Stanford University CA

December 15, 2022 - February 28, 2023

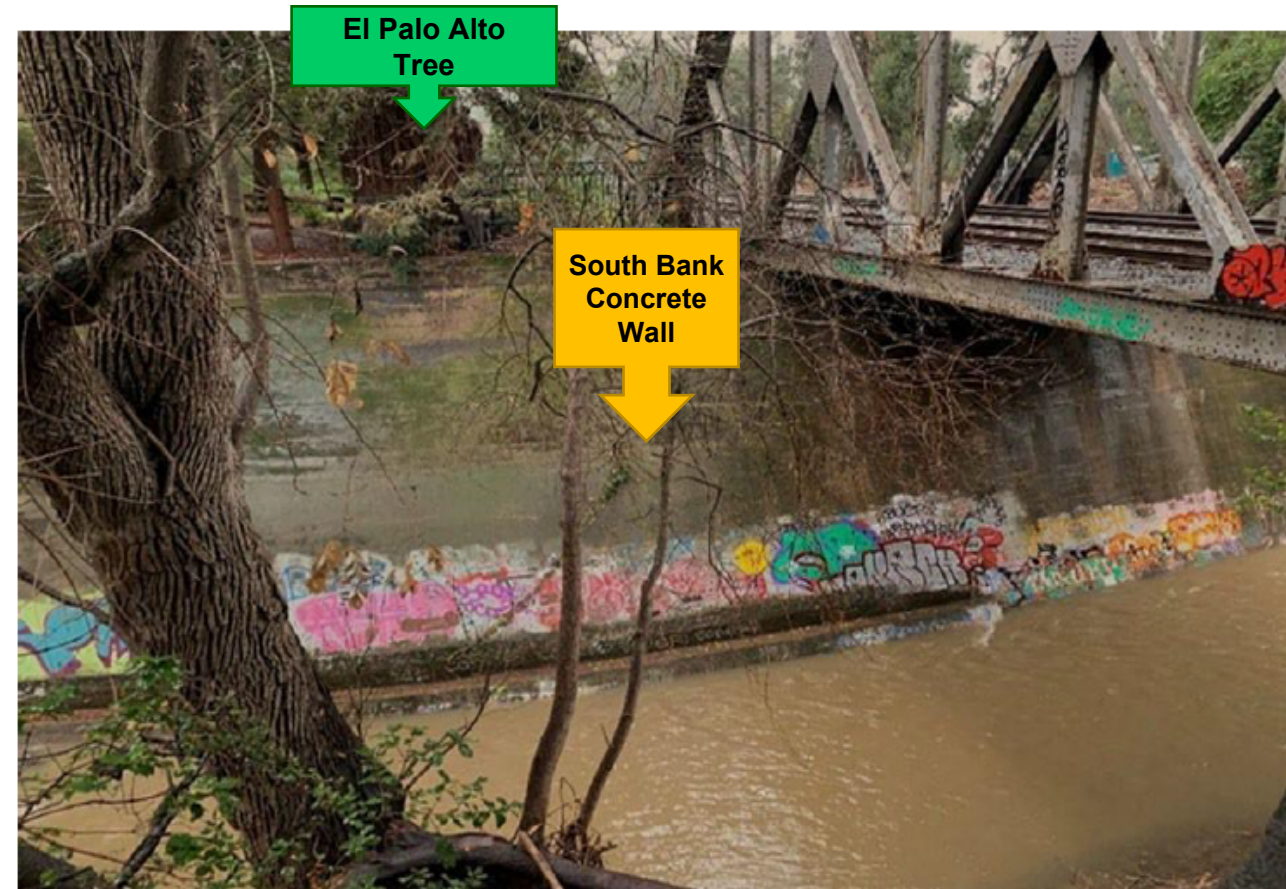
## South Embankment

- Creek water elevation **has receded** after the storm event and measures 25-feet below the bridge soffit
- South bank below the railroad bridge bearings has **concrete wall** providing protection for both the abutment and **historic Palo Alto Tree**
- **Moderate scour** has been observed at the toe of the concrete wall due to high water velocity

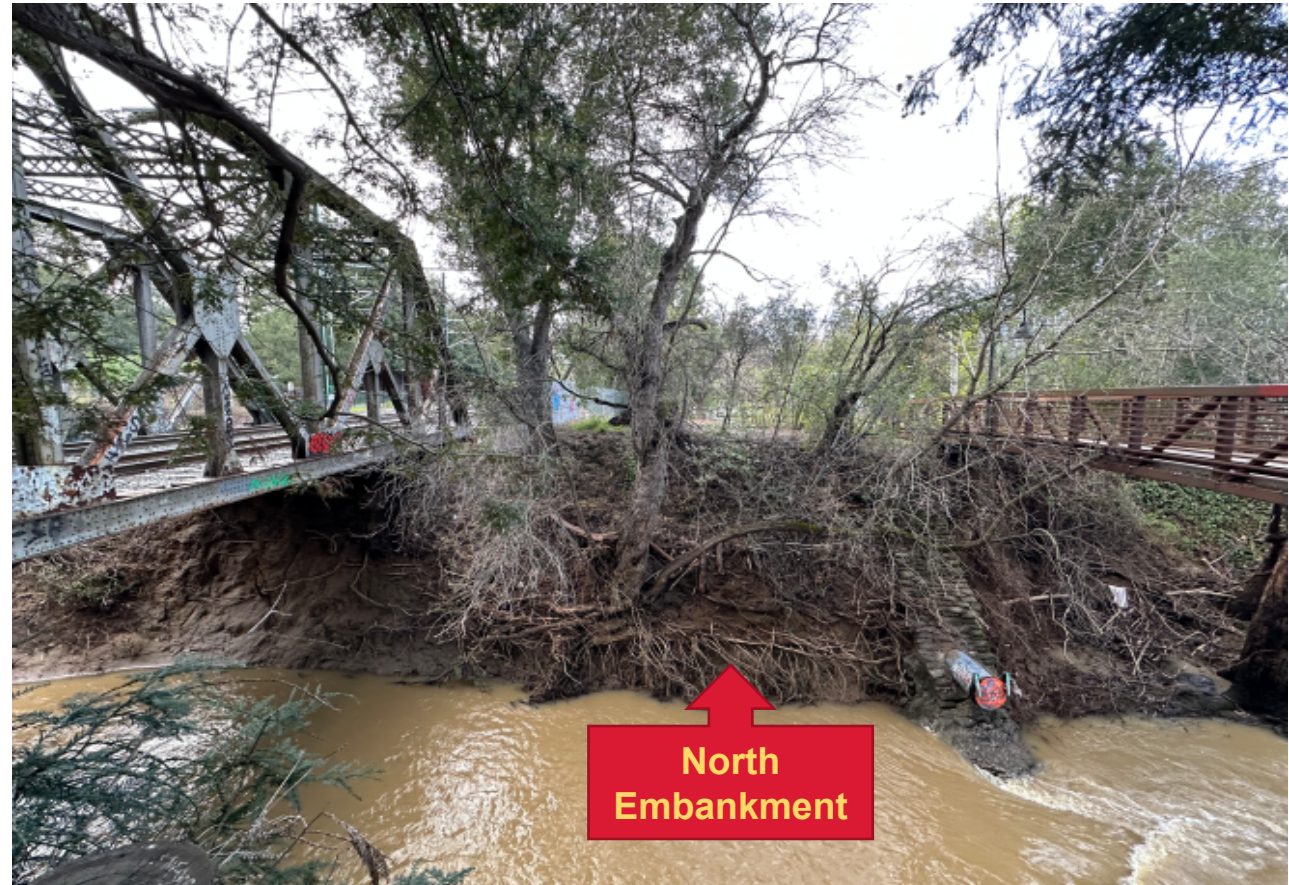
## North Embankment Scour

- North bank abutment slope protection below **Caltrain's railroad bridge** has been **severely scoured** and **undermined** to a near vertical condition
- The adjacent slope embankment and large diameter **tree root mats** are showing signs of significant **erosion** and **scour**
- Current conditions **exceed 1.5 to 1** maximum for soil slope stability
- Soil will continue to **erode** and become **unstable** without mitigation

- **Railroad bridge** abutments must be **backfilled** to a minimum of 1.5 to 1 or greater to **provide soil slope stability**
- **Slope protection** measure required on top of the soil to reduce risk of erosion and future bridge embankment scour
- Caltrain working with existing on-call design bench teams to develop a **suitable restoration repair** for permitting agencies review and approval

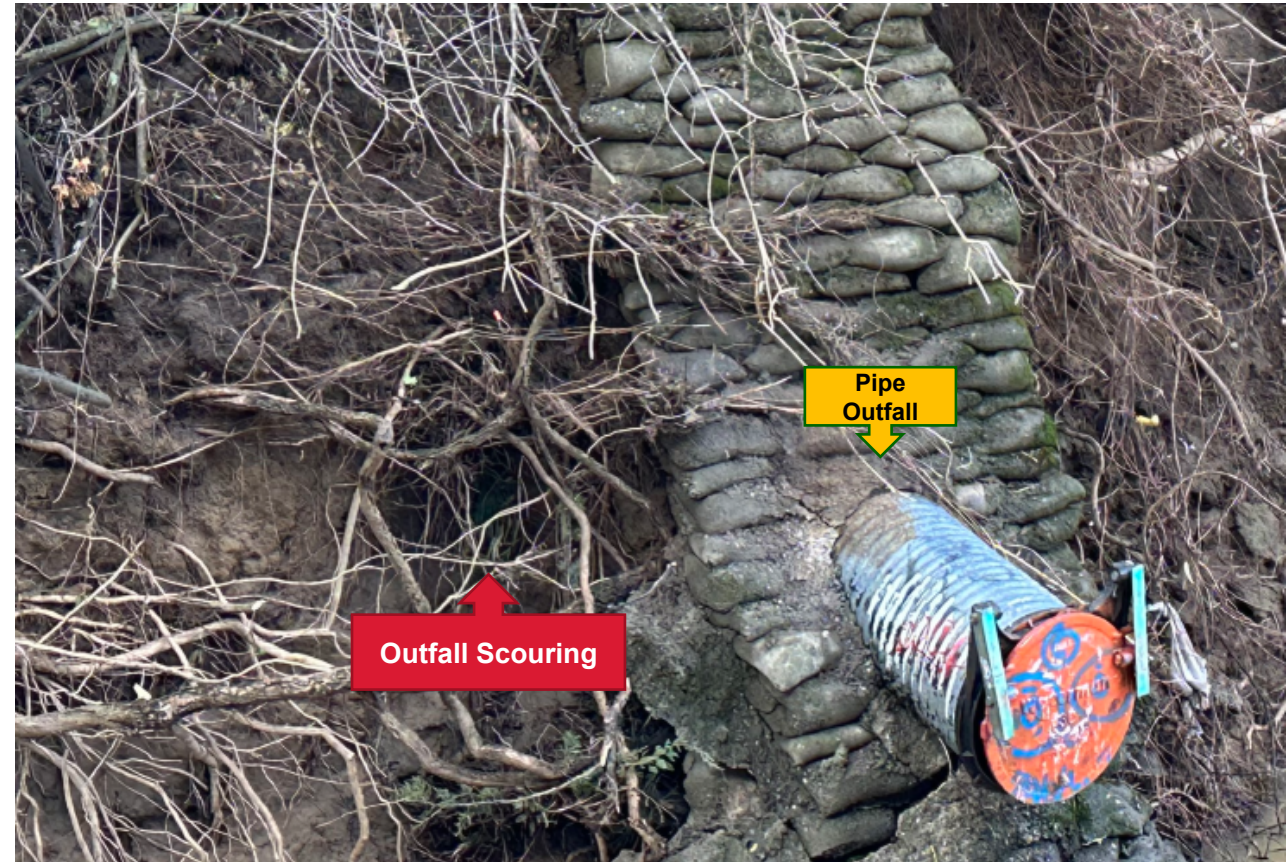
## Outfall Embankment Scour

- Nearby storm **drainpipe outfall** from Palo Alto Park has also experienced **severe scour** and **embankment erosion**
- Outfall slope cement bags protection has **lost** supporting soil compromising the **structural integrity**

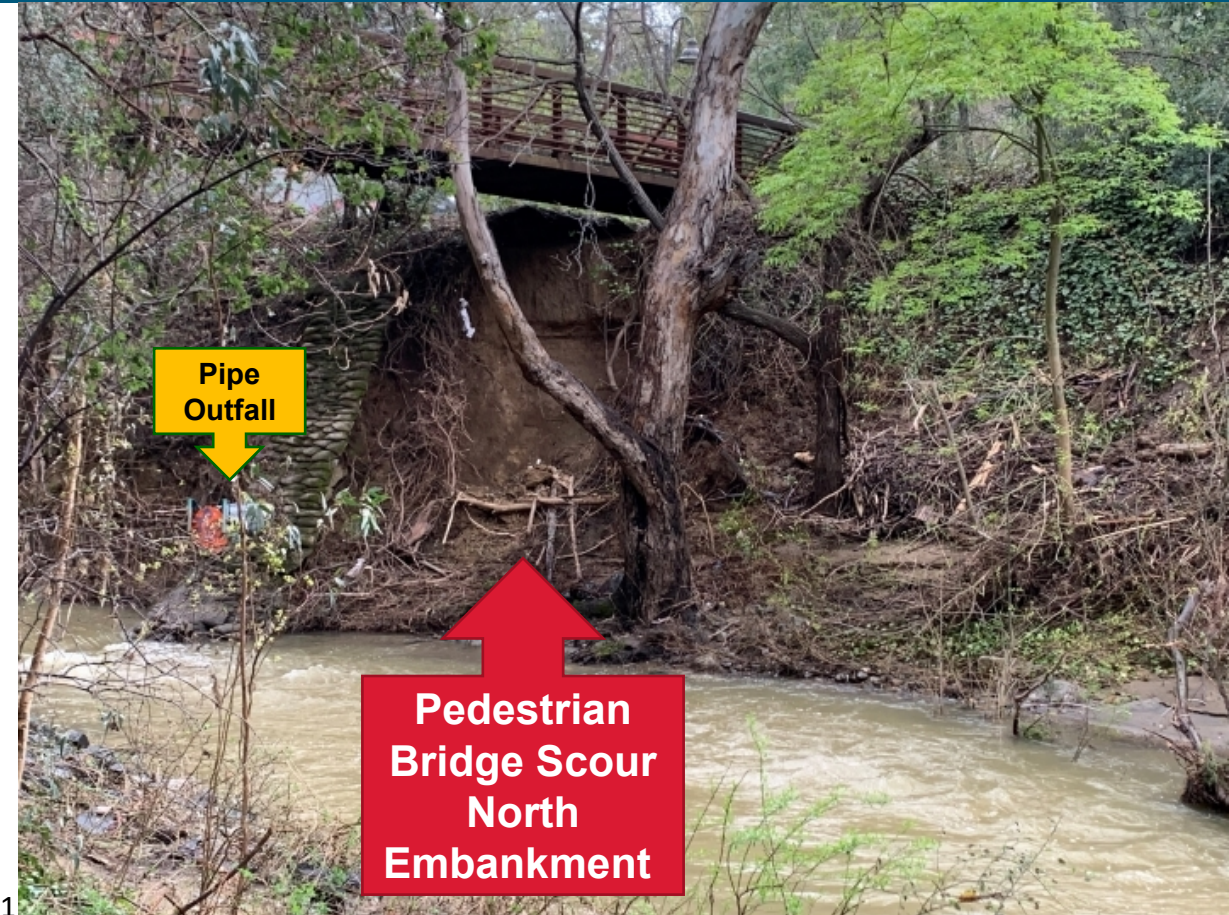
## Pedestrian Bridge Embankment Scour

- Palo Alto Park's **pedestrian bridge** abutment slope protection has also been **severely scoured** and **undermined** to a near vertical condition
- Current conditions **exceed 1.5 to 1** maximum for soil slope stability
- Soil will continue to **erode** and become **unstable** without mitigation
- Caltrain will continue to coordinate with **Palo Alto** and **Menlo Park** regarding post storm conditions

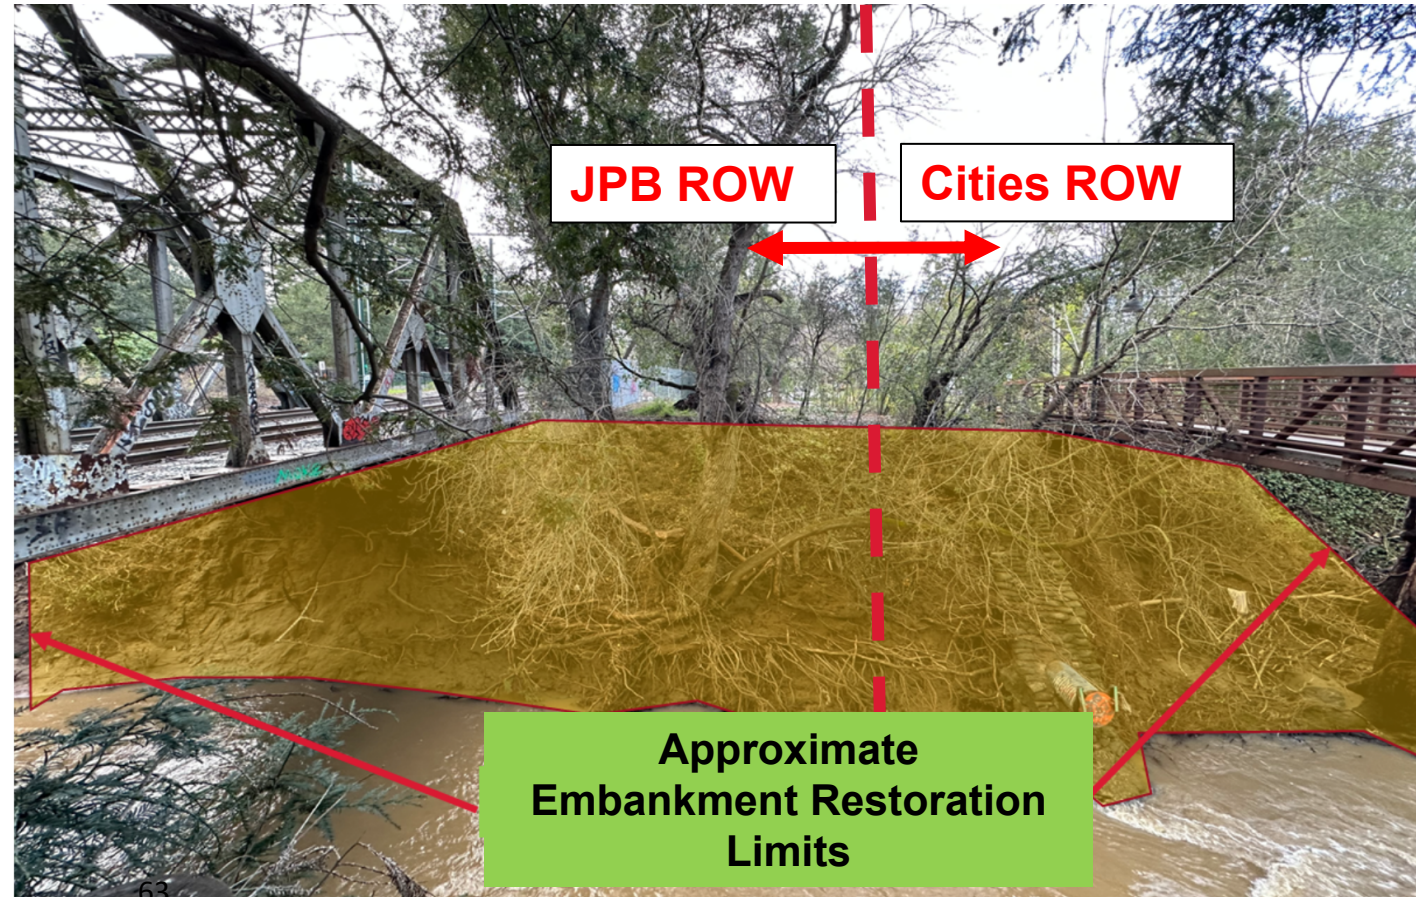
# San Francisquito Creek Embankment Restoration Limits

- Approximate restoration **limits** from **east** of Caltrain's railroad bridge to **west** of Palo Alto's pedestrian bridge (shaded area)
- Embankment restoration **extent** and **method** subject to **hydraulic** modeling analysis and approval from the environmental **permitting agencies** and coordination with **adjacent property owners**
